**Flood Control Project Maintenance
Levee Inspections**

Maintenance Issue Types Only, Levee Inspection Report By Mile - Spring 2019

Sacramento River West Side Levee District

Waterway	Bank	Unit Miles	Inspection Start/End	Inspector
Unit No. 01 Sacramento River	Right	49.64	04/02/2019 04/03/2019	Zach Jojola

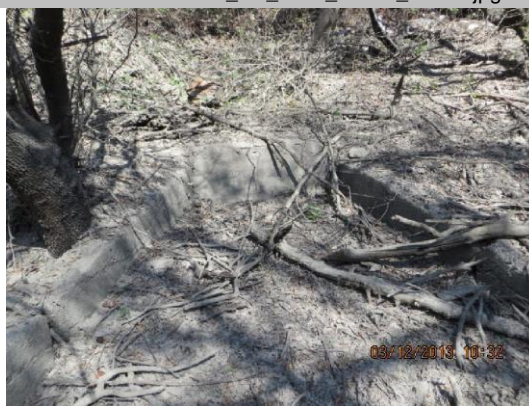
Photo 1 of 1 : UCIP_SP_2019_10088_17237.jpg

Concrete headwall visible on WS toe.

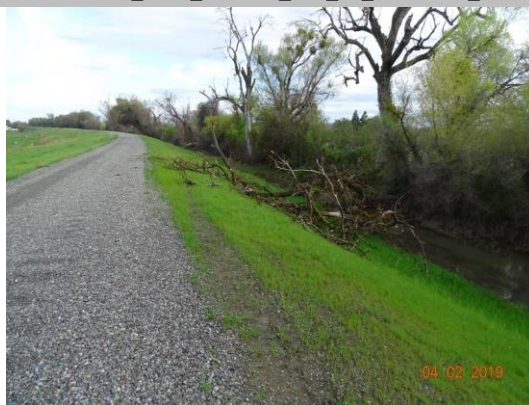
Photo 1 of 1 : SP_2019_NA0016_435_76_20190404_00210.jpg

LM Start	2.09	Rating **	M	Issue No.	76
LM End	2.09	Issue Type +	Ma	Location *	WS
Category	Earthen Levee			GPS Latitude/Longitude	
				Start	End
Item	Encroachments			38.828597 °	38.828597 °
				-121.726049 °	-121.726049 °
DWR ID	DWR_NA0016_01_s_2019_76				
Comment Code					
TR : Tree or limb					
Inspector Comment					
A fallen tree is located on the waterside slope.

View of fallen tree on the waterside slope. Spring 2019.

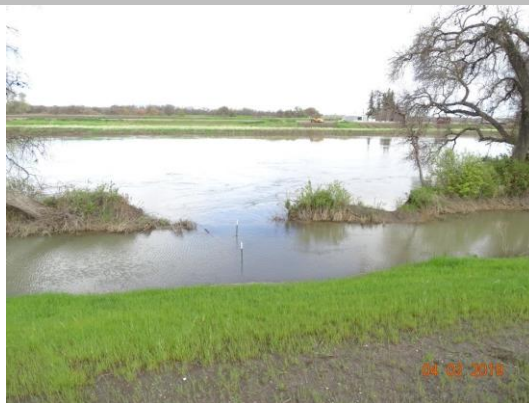
Photo 1 of 4 : SP_2019_NA0016_435_112_20190404_00211.jpg

LM Start	8.55	Rating **	A/W	Issue No.	112
LM End	8.55	Issue Type +	Ma	Location *	WS
Category	Earthen Levee			GPS Latitude/Longitude	
				Start	End
Item	Erosion / Bank Caving			38.857422 °	38.857422 °
				-121.780870 °	-121.780870 °
DWR ID	DWR_NA0016_01_s_2018_112				
Comment Code					
E1 : Note and monitor erosion site.					
Inspector Comment					
Location on waterside berm where oak tree fell and removed soil around the roots. New erosion as of the Spring 2019 inspection date. Recommend monitoring.

View of erosion on the waterside berm. Spring 2019.

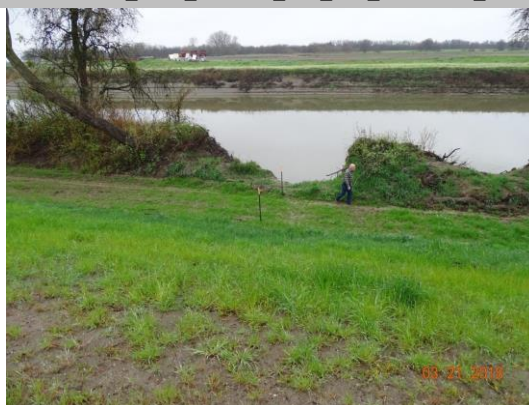
Photo 2 of 4 : SP_2019_NA0016_435_112_20190304_00040.jpg

View of the berm where the oak tree used to stand, facing the Sacramento River. Spring 2018.

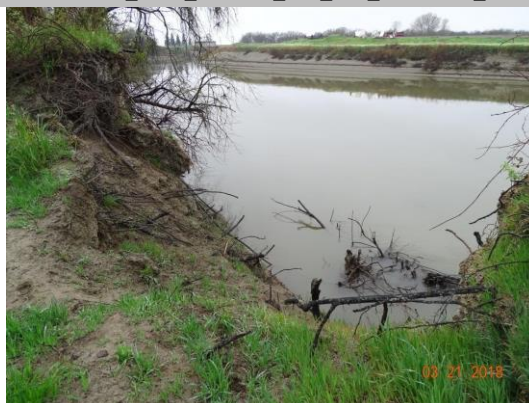
Photo 3 of 4 : SP_2019_NA0016_435_112_20190304_00041.jpg

View of the remaining roots, facing upstream. Spring 2018.

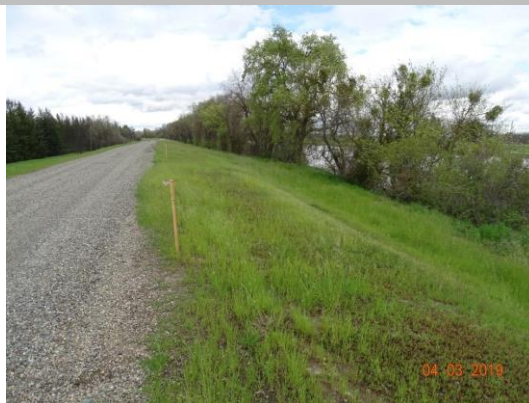
Photo 1 of 2 : SP_2019_NA0016_435_81_20190404_00212.jpg

View of levee crown where LMA has placed monitoring stakes. Spring 2019.

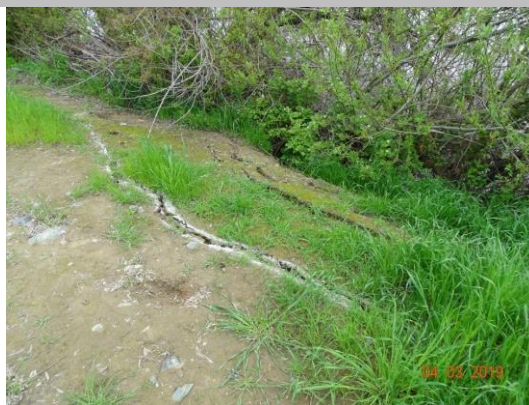
Photo 2 of 2 : SP_2019_NA0016_435_81_20190404_00213.jpg

View of cracking on the waterside berm. Spring 2019.

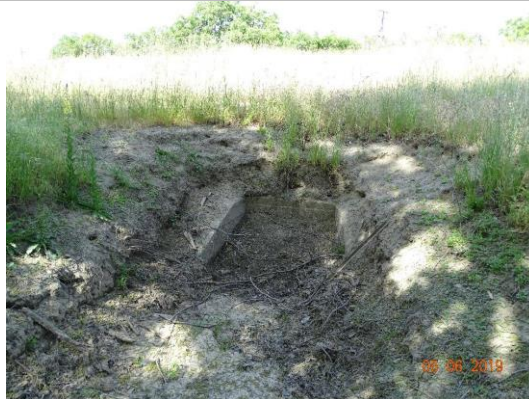
Photo 1 of 3 : UCIP_SP_2019_53982_79209.jpg

Slide gate silted on WS end

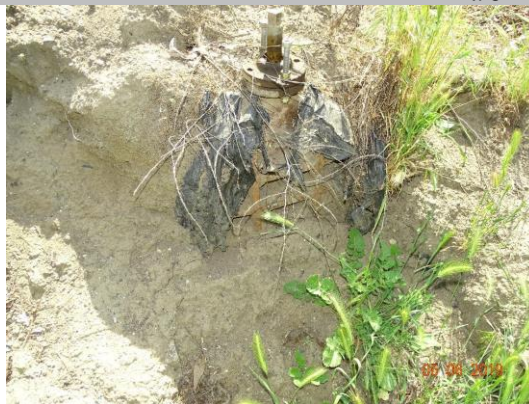
Photo 2 of 3 : UCIP_SP_2019_53982_79210.jpg

Gate valve silted at LS toe. Missing handwheel

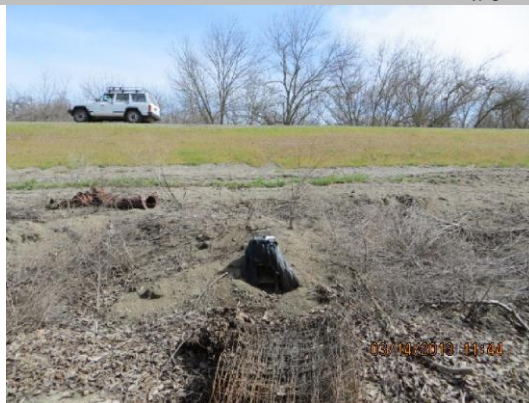
Photo 3 of 3 : UCIP_SP_2019_53982_17548.jpg

Gate valve buried on LS toe

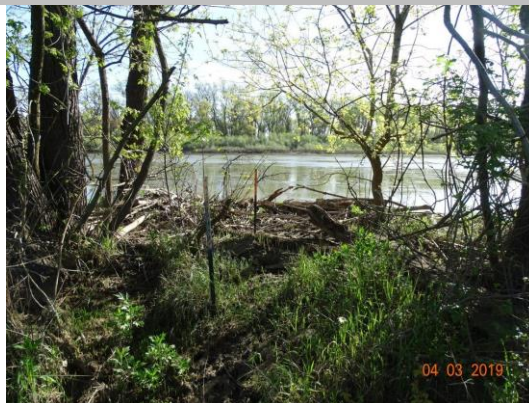
Photo 2 of 5 : SP_2019_NA0016_435_114_20190404_00215.jpg

View of the middle stake on the waterside berm. Spring 2019.

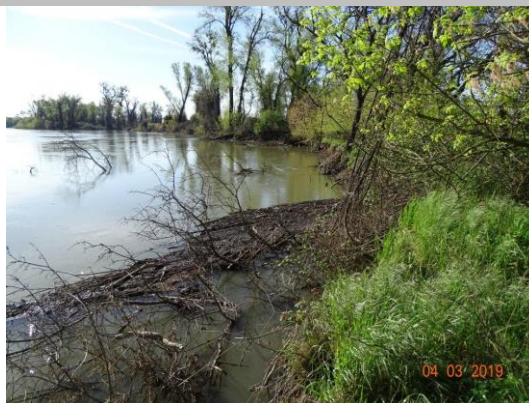
Photo 3 of 5 : SP_2019_NA0016_435_114_20190404_00216.jpg

View of the erosion site facing downstream. Spring 2019.

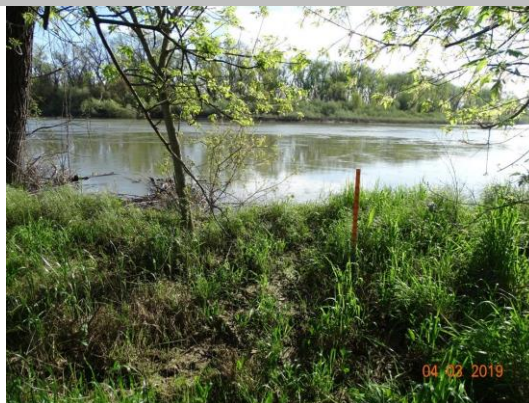
Photo 4 of 5 : SP_2019_NA0016_435_114_20190404_00217.jpg

View of the upstream stake on the waterside berm. Spring 2019.

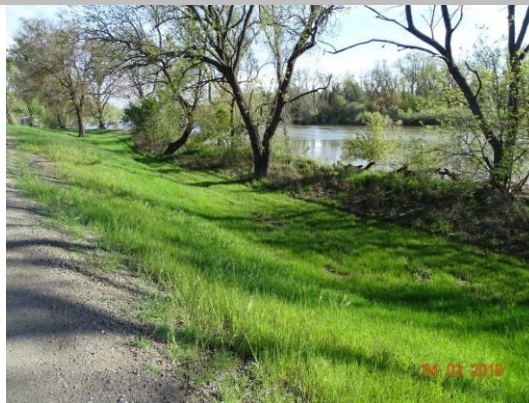
Photo 5 of 5 : SP_2019_NA0016_435_114_20190404_00218.jpg

View of the erosion site from the crown, facing upstream. Spring 2019.

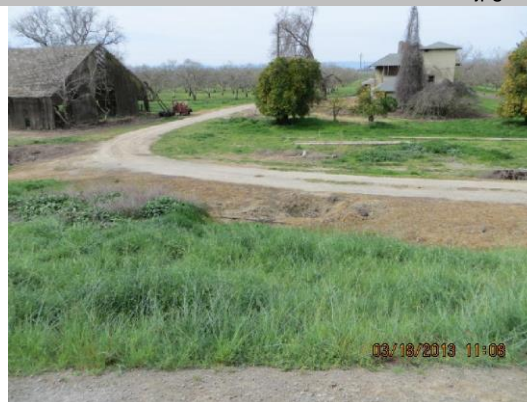
Photo 2 of 3 : UCIP_SP_2019_10426_17704.jpg

Headwall and gate valve on LS toe buried but partially exposed.

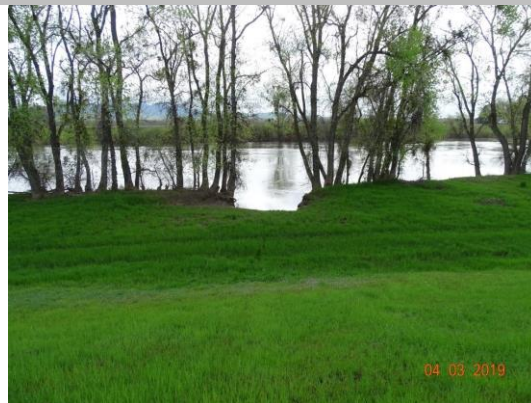
Photo 1 of 1 : SP_2019_NA0016_435_119_20190404_00219.jpg

View of erosion from the crown. Spring 2019.

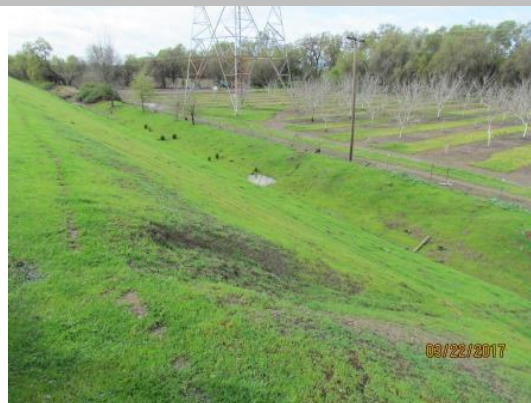
Photo 1 of 2 : SP_2019_NA0016_435_146_20190304_00056.jpg

Slope stability issue due to foot traffic. Spring 2017.

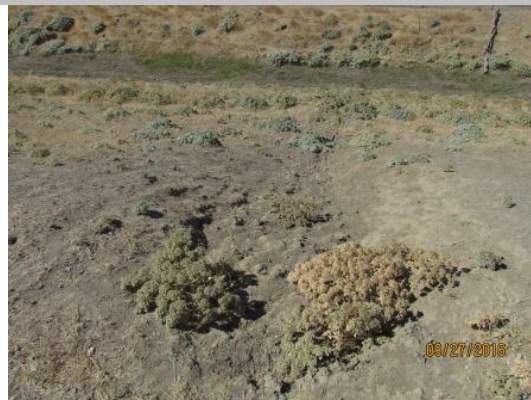
Photo 2 of 2 : SP_2019_NA0016_435_146_20190304_00057.jpg

Slope stability issue due to foot traffic. Fall 2016 inspection.

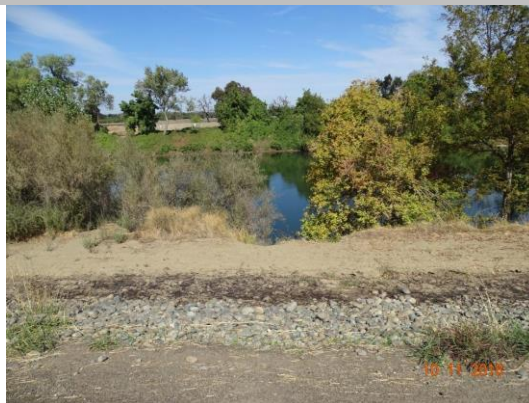
Photo 1 of 1 : SP_2019_NA0016_435_113_20190304_00043.jpg

View of erosion on the waterside berm. Fall 2018.
